**HOOSIER HERITAGE PORT AUTHORITY RAILROAD
TRACK INSPECTION REPORT
AND
REHABILITATION PLAN
Tipton, Hamilton and Marion Counties**

**Hoosier Heritage Port Authority Railroad
Track Inspection Report & Rehabilitation Plan**

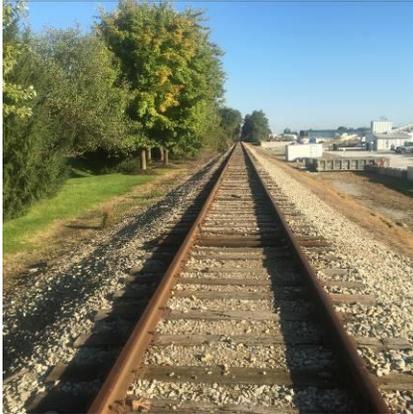
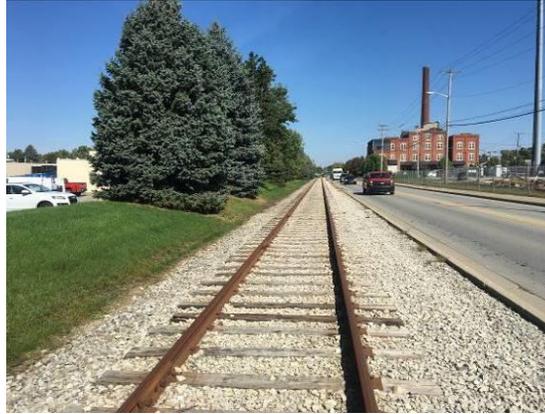
A sag was filled in over an under-grade drainage facility adjacent to the Indiana Transportation Museum which was brought up by Mrs. Klopfenstein and Mr. Schwartz. Also Bridge 38.87 had a sagging Southern approach. As typical with bridges, even on roadways, the transition from the existing approaches to the more solid structure often creates vertical surface problems. The sag on this approach is probably not due to any subgrade failure, however.

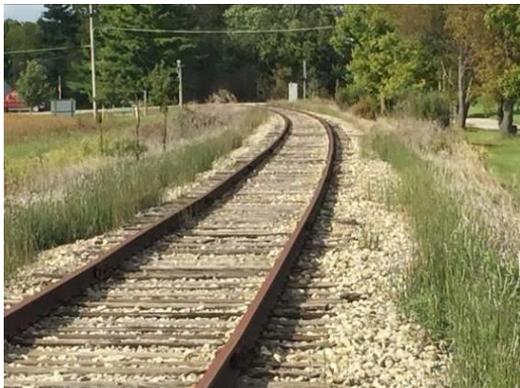
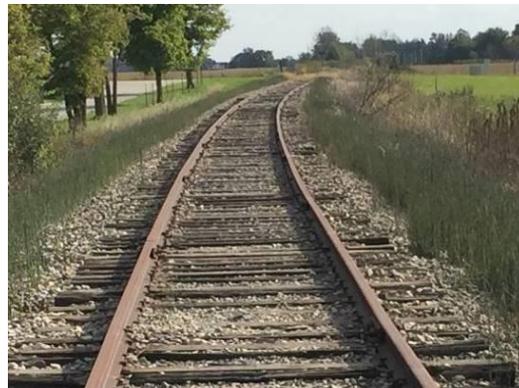
One location on the north end had a very hard to kill plant on the shoulders of the track which the Consultant is familiar with. It is an ancient plant growth called “Equisetum” or “horsetail” and is typically not affected by typical weed spraying. It is prudent to mention this type of plant to the weed spraying contractor in advance. Many national track weed spraying contractors are familiar with this particular vegetation.

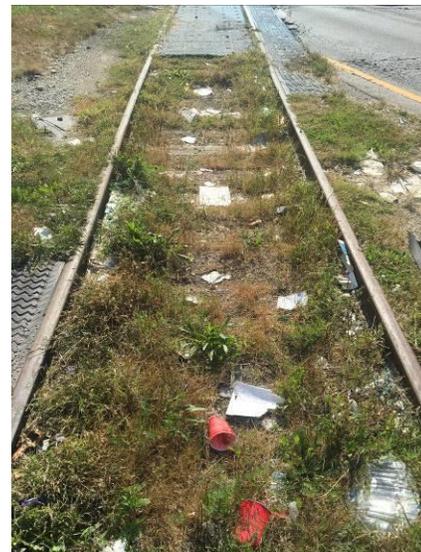
Median at Keystone Avenue

There are some grade crossings on the line that have dirt, fines and debris infiltrating the ballast section on the track approaches due to poor drainage flow paths from the adjacent roadway. To correct the drainage at some crossings could be a formidable task on both the budget and the maintenance effort. Every railroad, especially in the north where snow plowing is prevalent and anti-skid is applied to roadways for vehicle traction, the track suffers and the problems are further amplified.

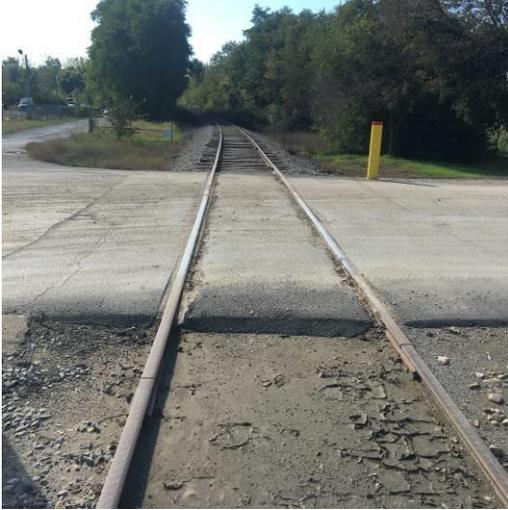
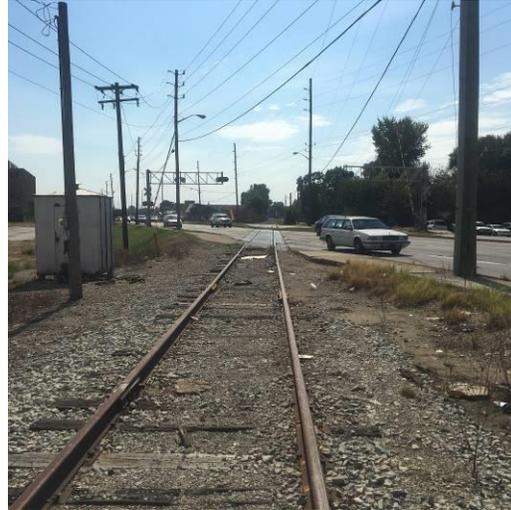
The crossings that have poor drainage conditions often create surface problems on the approaches to the crossings. Though there are a few crossings that have this condition it presently is not a problem due to the infrequency and slow speed of the rail traffic. The problems will become more prevalent on the subject crossings when the track is upgraded to Class Two level of speed and service. The impact of the higher speed on the track below magnifies track surface irregularities and the track becomes generally harder to maintain. As discussed above, the overall line has been well engineered and constructed with attention to drainage so therefore the Plan will need to concentrate on correcting these drainage issues using existing facilities and perhaps installing pipes and inlets during the rehabilitation effort.

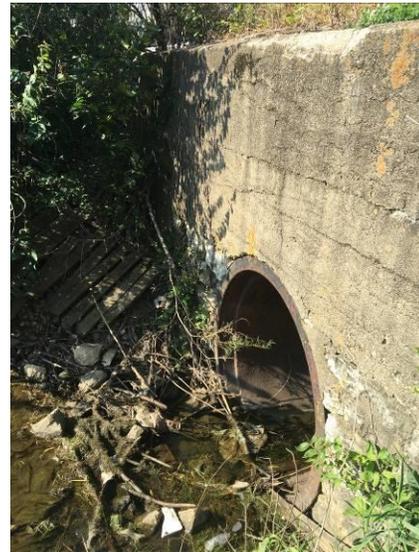
Sluice Pipe under Main Track

At 96th Street the right-of-way fills up with water during storm events on the southeast quadrant. It does not infiltrate the track or its subgrade but it creates some serious ponding that has become an issue with adjacent landowners. Further south, an estimated 500 feet, there is a turnout and side track on the east side of the Main track. A worn, corrugated galvanized pipe may have collapsed under the side track lead which has created the problem. The galvanized pipe outlets into a cross drain that goes under the railroad just south of the turnout and into the main drainage for the area to the north of the track. The inlet to the pipe is somewhat obstructed but needs to be cleaned out and perhaps the flow will be more adequate. Otherwise it may be prudent to put in another main track cross drain before the turnout and send the drainage to the west side of the track earlier.

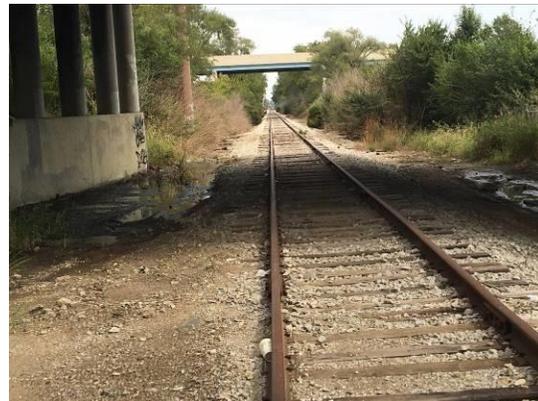
Typical of many railroads, brand new highway overpasses that cross over railroads don't design in adequate drainage for the railroad underneath and will ruin the track's ballast section by fouling it with dirt and fines during and after the construction of the bridge. The track at the Overhead Bridge where Route 52 intersects with I-69 will need to be cribbed or undercut to remove and replace the fouled ballast. Though that is not a problem now the higher speed will cause deleterious impact on the track surface.

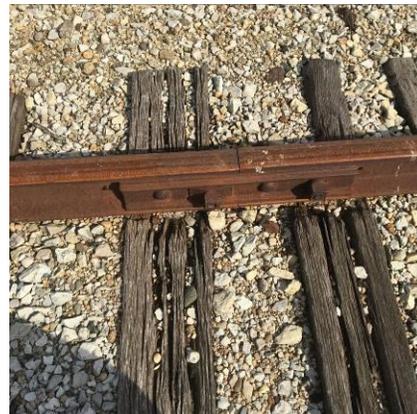
One exception is the joint ties. Of the eight tie samples taken from Fishers to 38th Street there were 7 joints that did not have any effective ties underneath or within the 24 inches either side of the rail end. (Refer above to Figure One). There were four joints with a five year or less life remaining tie under the joint and a defective tie. To rehabilitate the track to a reliable Class Two standard that will not lose its longevity within four or five years or less, the Consultant believes the defective tie under the joint should be replaced and share the joint burden with the five year tie.

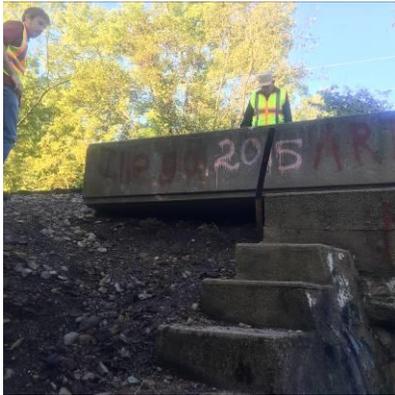
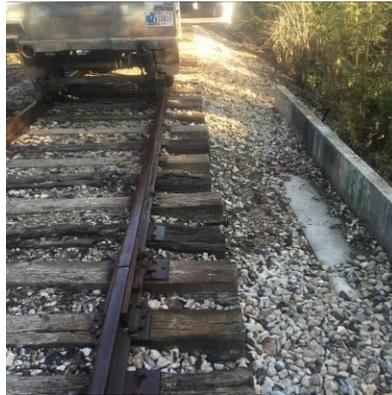
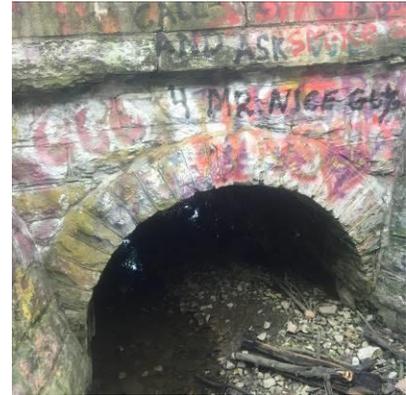
The six foot stone arch bridge at 18.30 had some minor grout loss at the west side wing wall which was undermining the southeast approach wall. Some shoring and ballast should be installed there and on the closed deck.

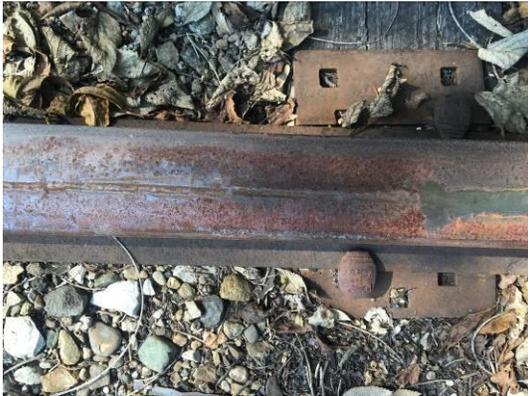
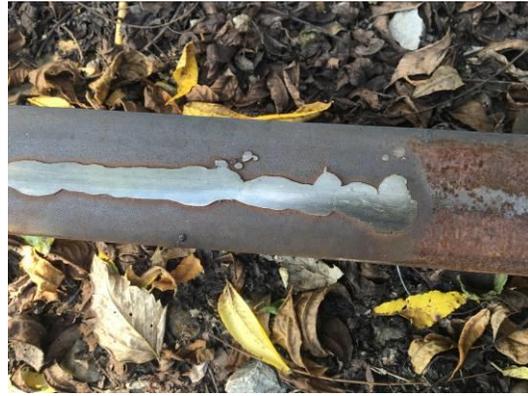
The most notable item on the entire inspection and something that this Consultant never encountered before, was a strange welded bead of what appeared to be stainless steel over the top of the center of each rail that was roughly three feet long and spaced about every

four feet on each rail head. The intermittent pattern started at the turnout at Fall Creek Milepost 6.1 and extended to roughly 900 feet north of 39th Street.

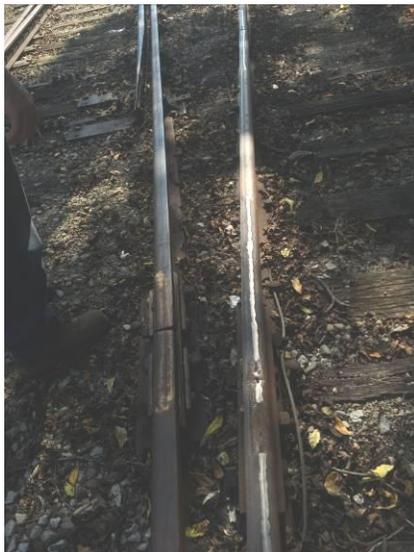
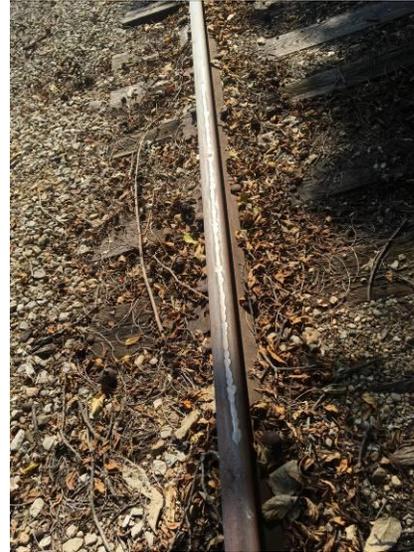
On further investigation, the material is stainless steel and is welded into an electric arc burned groove in the center of the rail head that maintains the electric shunt in rusty rail conditions so the circuit is not lost when trains are approaching grade crossings that are protected with electric warning devices. There is a railroad in Minerva, Ohio that performs the same procedure to maintain the circuit and it is conjectured that it was developed and implemented by the same owner.

The stainless “bead” has peeled up in certain locations and the Consultant feared it could pierce the rubber tires of the hy-rail during the inspection. It did not, but the peeled up sections revealed the “burned head” below which creates an even greater fear, that the burned rail has compromised the integrity of the rail. A broken head at 10 miles per hour is not a “good thing”.

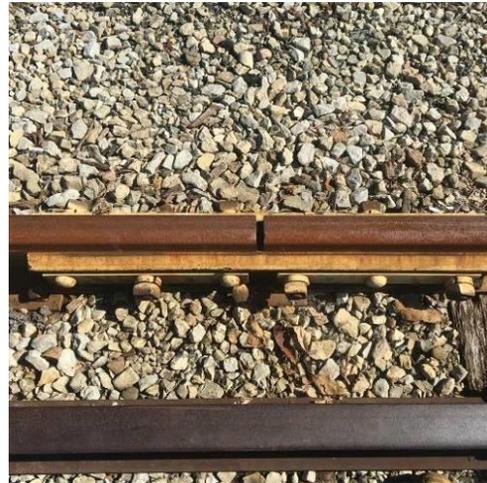
The picture to the right shows an insulated joint on the south approach to Bridge 22.62. The track is curved and the high side rail is curve worn. Though the curve wear is hard to see in the picture of the painted insulated joint, the width of the head of the adjacent inner track guard rail can reveal the magnitude of the curve wear on the running rail. **Though the gauge wear is significant, the rail probably has significant life remaining.**

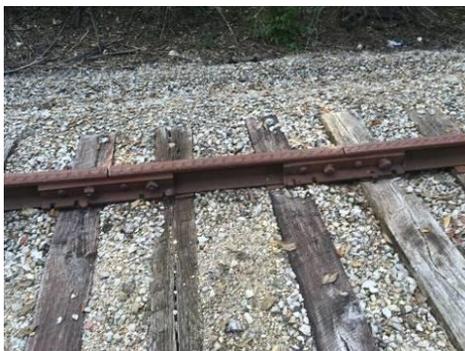
The inspection revealed a small number of "Dutchman" from one end of the line to the other. A "Dutchman" is a short section of rail anywhere from an inch to 10 feet or more where the rail has broken off and is either jointed in the track with joint bars on both ends and very close to one another or a short piece of rail that is secured within a joint bar by a bolt within that jointed section. The short piece of rail may be within the joint bar limits and not bolted but still "relatively" secured with the adjacent joint bars (splice). Typical of industry trackage, Dutchman are a quick and easy repair for the ends of the rail which might simply break-off the rail end and are still secured by the joint bars. Most Dutchman are not problematic but will become problematic in the future especially under Class Two level of service. The "Dutchman" will be replaced with the rehabilitation effort and are included in the Plan as a "Miscellaneous Rail Replacement" contingency item.

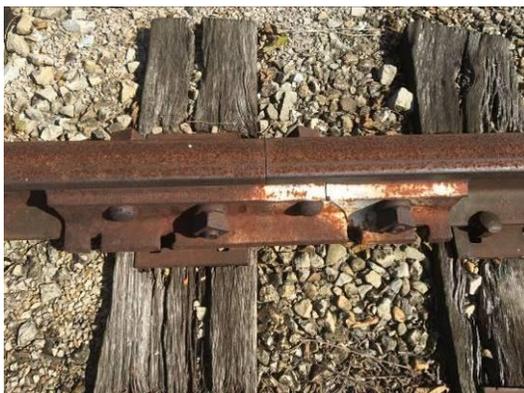
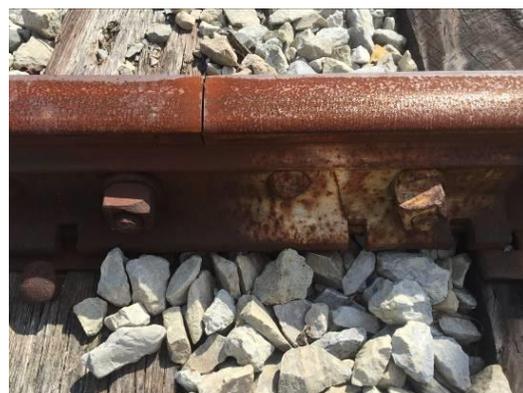
The line had an inordinate amount of **cracked and broken bars**. They were no doubt previously **identified however because they were paint marked by a previous inspector**. The propensity of the **cracked bars were typically between the outside bolt holes and did not need to be replaced in 10 mile per hour traffic**. Though **cracked bars of the defect described are allowed in Class 2 track**, a healthy contingency of **replacement bars will be included in the rehabilitation plan** and will be replaced when the work commences. The inspection found numerous cracked bars but there were **no bars that were singularly or both broken in the center that would warrant immediate replacement**.

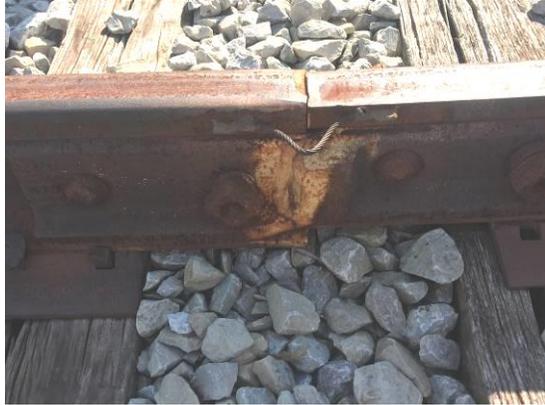
There were two sets of compromise joint bars found that were welded together at the center just south of 96th Street. They, like the cracked bars were paint marked by a previous inspector and are obviously being watched, however they will require replacement in the rehabilitation also.

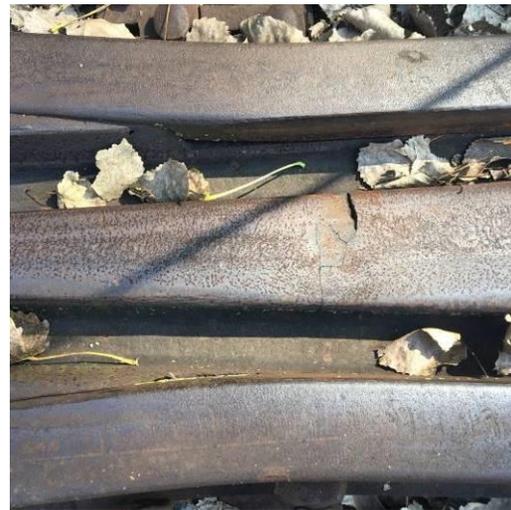
A cracked frog point is sometimes “weld-able” if it does not migrate through the entire point and definitely into the casting. It has been the prudent action to simply replace the frog then to attempt to cut out the fracture and build the point from scratch. Even the best of frog welders cannot always make a weld of this magnitude and have it last for any length of time. The fact that the track will be raised to Class Two level of service negates the option of welding. The frog must be replaced.

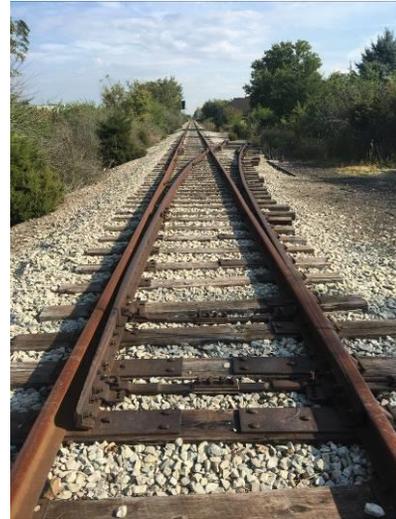
South of 96th Street Crossing

The picture below shows switch timber in place on the Main Track just south of the above turnout. The prior turnout has been straight railed (taken out). In order to surface the track efficiently and the surface to “hold”, straight railed turnout timber must be replaced with regular ties.

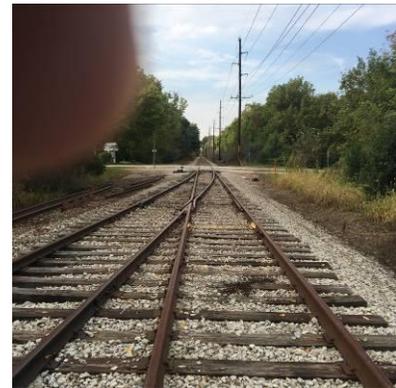
South of Milepost 16 (South Run-around Turnout – Fishers) – Switch rods are close to switch timber, mildly chipped reverse left hand point. Switch timber are good but measurement for Face and Check gauge need correction on reverse move.

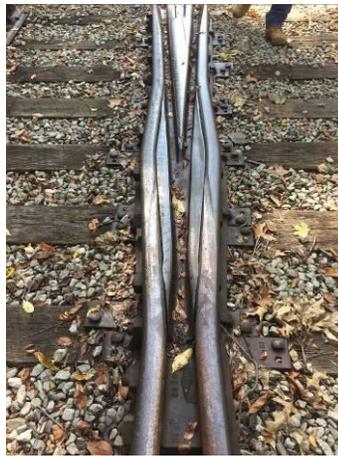
South Wye Turnout – Frog bolts are loose.

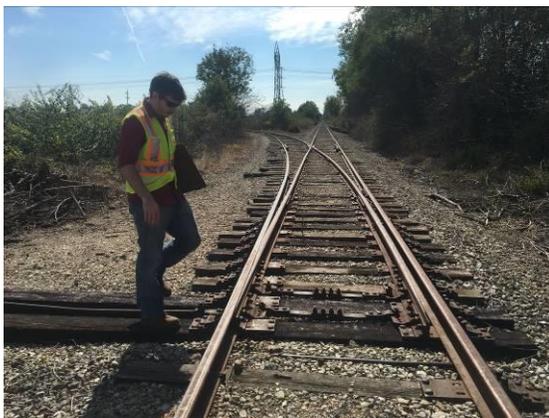
North Wye Turnout – Risers on frog need welded.

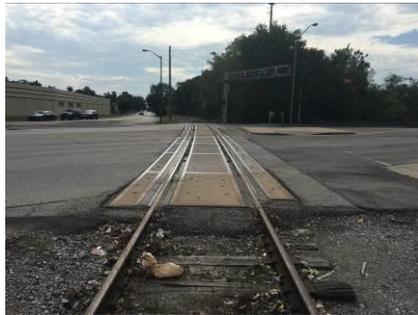
MP 5.1 – 38th Street

MP 5.1 - 38th Street The north approach to the crossing will require additional cross ties. Typical and similar to a production tie replacement gang at inner track guard rails over bridges, insulated joint ties that require replacement are often overlooked because of the fear of breaking the wires, especially if there is not a signal maintainer available to repair them. The track looks solid as evidenced by road traffic but there are numerous inside rubber flanges missing.

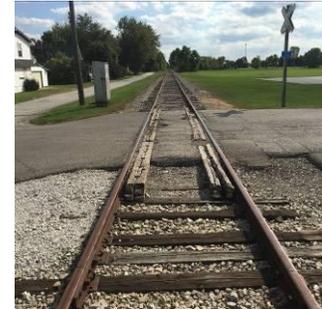
MP 34.3 – Kauffman St.

MP 34.3 – Kauffman Street Crossing has broken up flangeway timbers that should be removed. Timber can possibly be “kicked up” under train and/or vehicle traffic and do damage to the undercarriage of either. The track appears solid. Removal of the flangeway timber and accompanying asphalt paving should provide a flangeway for safer higher speed train traffic.

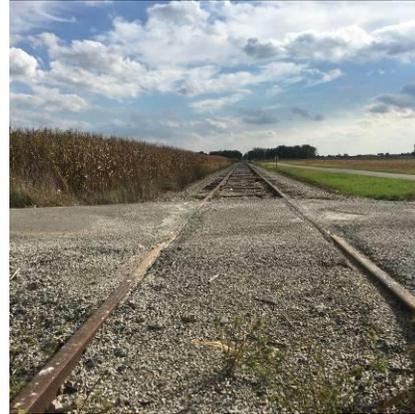
MP 36.1 – County Route 450 Gauge is 58” within crossing and has been tar and chipped filling in the flangeways. Crossing track and surface must be fully replaced.
