MONON STUDY

ENGINEERING REPORT

January 1986

Reid, Quebe, Allison, Wilcox & Associates, Inc.

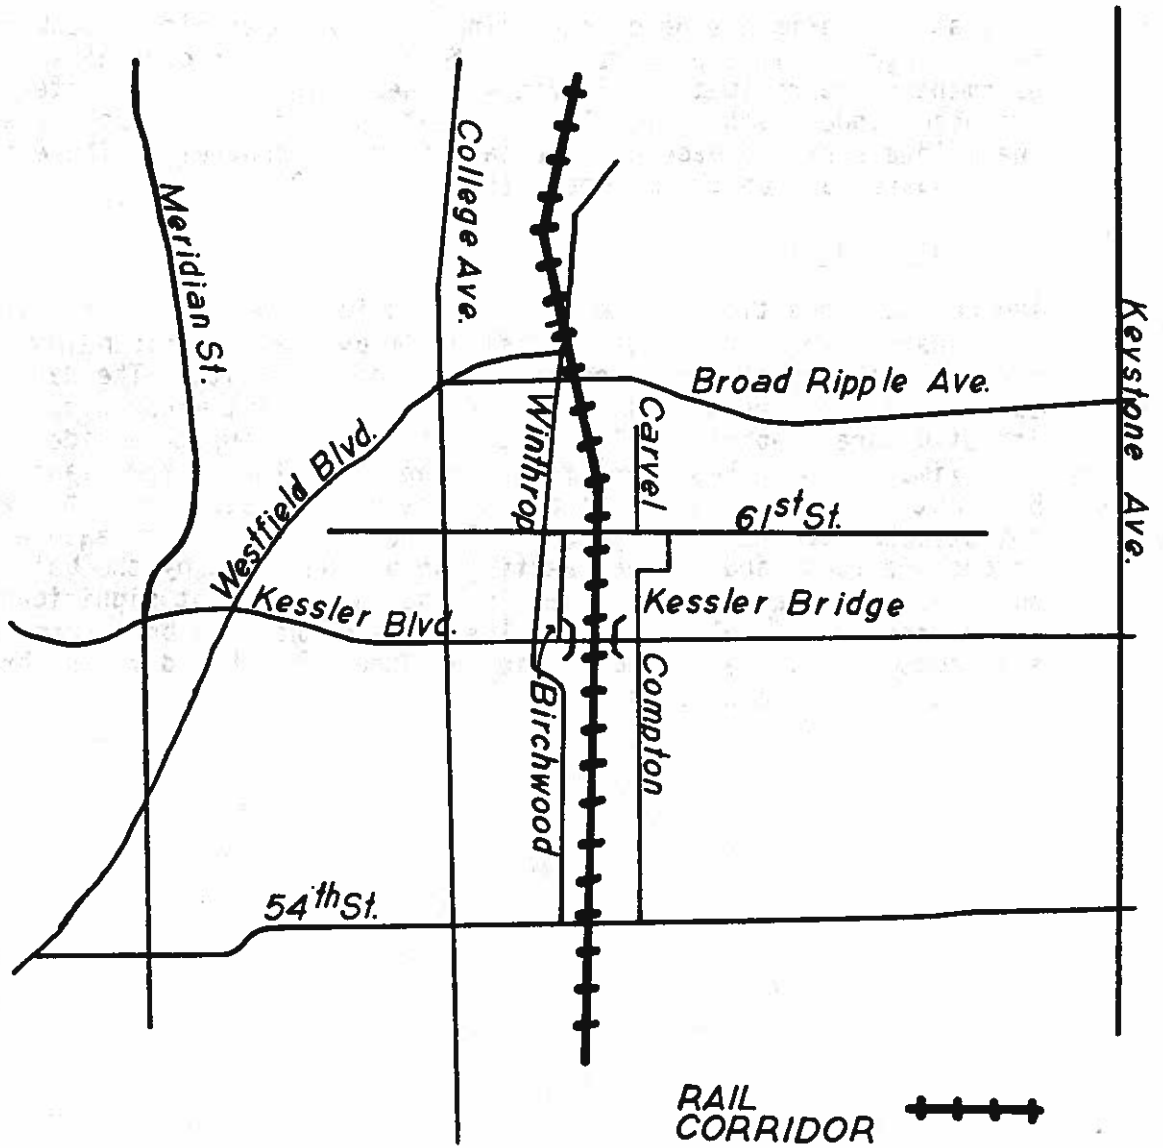
KESSLER BRIDGE

The general condition of the abutments is fair to good. The outside steel beams have both been damaged by being hit by road traffic below. The damage to the outside beam on the east side is minute. The damage to the outside beam on the west side is more extensive but minor with respect to its structural capacity. The bottom of the beam (west-outside) is bowed approximately 3 inches where it has been hit. The bottom flange has not been cut and there appears to be no loss of beam section. The beams are not attached to the substructure. The rail and ties near each end of the bridge are loose and are not resting on or supported by the ballast. In summary, the damage to the beams is minor and does not significantly affect the structural capacity. The beams do need to be secured to the substructure. Ballast should also be added at each end of the bridge to support the ties and rails.
