**HOOSIER HERITAGE PORT AUTHORITY RAILROAD
TRACK INSPECTION REPORT
AND
REHABILITATION PLAN
Tipton, Hamilton and Marion Counties**

**Hoosier Heritage Port Authority Railroad
Track Inspection Report & Rehabilitation Plan**

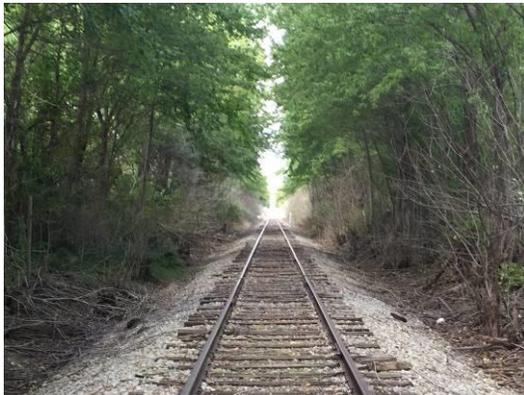
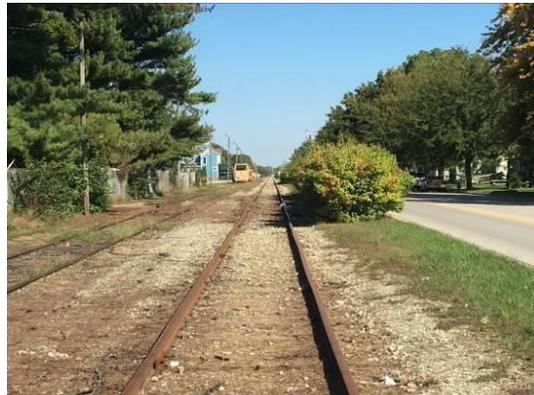
North of Carbon Street

The propensity of the vegetation encroaching on the track structure may not be fully “fouling” the track currently as described in the above Track Safety Standards, but it was identified at numerous locations along the single track as potential to foul in the near future. With this in mind, it is prudent to address the brush cutting during the initial rehabilitation effort which typically minimizes the cost of the work since it is done with already mobilized contractors and avoids the necessity of returning to perform the work at a short juncture after the rehabilitation is complete. The Railroad does not have operable windows on its passenger cars but brush and overhanging limbs should be removed to maintain personnel and passenger safety as well as conforming to the FRA safety standards.

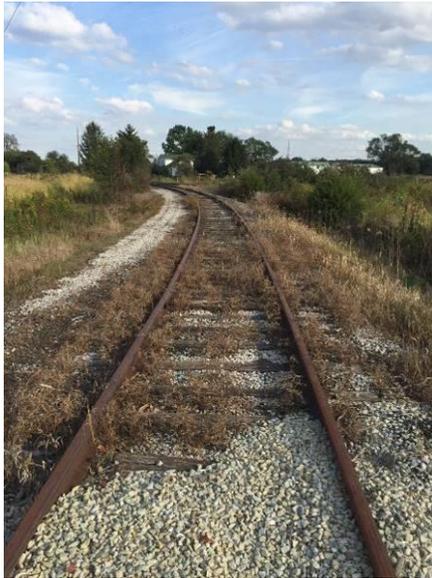
There was only one location where the inner track weeds were significantly prevalent and that was on the south leg of the Wye track in Davin.

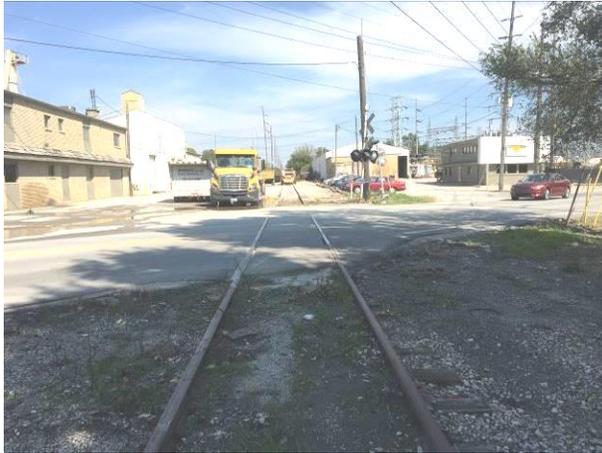
Regarding overall drainage, it was evident that the railroad was very well engineered and constructed originally and maintained throughout the course of time. Rarely does a track inspection over 37 miles of track exhibit such a high and dry right-of-way with so few drainage problem locations. There were only a few “standing” water locations identified where the drainage was infiltrating the track structure along the entire railroad. Those included 56th Street where the hy-rail truck had to be taken off the track and set back on after skipping between Kessler Boulevard and 56th Street due to the track equipment occupying the track. The other location was between the embedded street running track at Logan Street in Noblesville and the two bridges north.

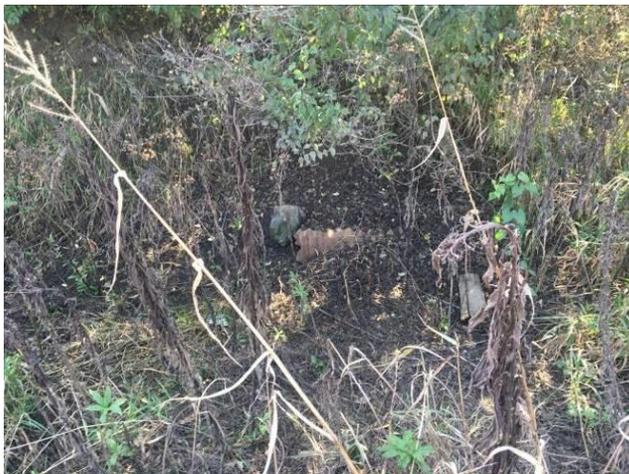
Galvanized Pipe Under Siding

At 96th Street the right-of-way fills up with water during storm events on the southeast quadrant. It does not infiltrate the track or its subgrade but it creates some serious ponding that has become an issue with adjacent landowners. Further south, an estimated 500 feet, there is a turnout and side track on the east side of the Main track. A worn, corrugated galvanized pipe may have collapsed under the side track lead which has created the problem. The galvanized pipe outlets into a cross drain that goes under the railroad just south of the turnout and into the main drainage for the area to the north of the track. The inlet to the pipe is somewhat obstructed but needs to be cleaned out and perhaps the flow will be more adequate. Otherwise it may be prudent to put in another main track cross drain before the turnout and send the drainage to the west side of the track earlier.

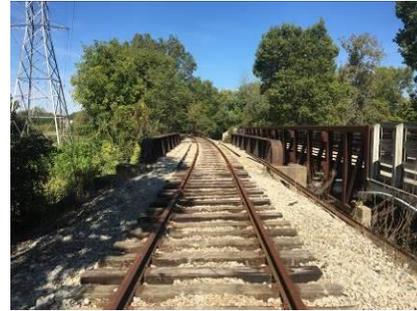
Bridges 20.71 and 20.80 both had good bridge deck timber and well distributed effective ties on the approaches under the “nose” of the inner track guard rail. Bridge 22.62 in Noblesville requires additional ties on the south end approach within the nose area of the inner track guard rail. Gauge at this location measured 57-5/8”. All the ties between Bridge 22.62 and 22.69 have been recently replaced and the rail on the high side of the curve through Bridge 20.80 was replaced.

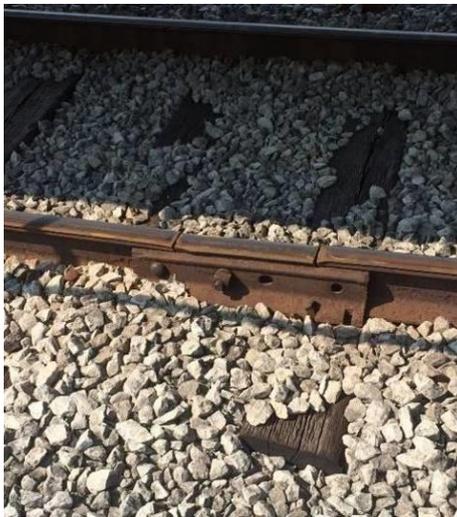
The above picture was not from HHPA Railroad but is included as an example of a "Dutchman".

The inspection revealed a small number of "Dutchman" from one end of the line to the other. A "Dutchman" is a short section of rail anywhere from an inch to 10 feet or more where the rail has broken off and is either jointed in the track with joint bars on both ends and very close to one another or a short piece of rail that is secured within a joint bar by a bolt within that jointed section. The short piece of rail may be within the joint bar limits and not bolted but still "relatively" secured with the adjacent joint bars (splice). Typical of industry trackage, Dutchman are a quick and easy repair for the ends of the rail which might simply break-off the rail end and are still secured by the joint bars. Most Dutchman are not problematic but will become problematic in the future especially under Class Two level of service. The "Dutchman" will be replaced with the rehabilitation effort and are included in the Plan as a "Miscellaneous Rail Replacement" contingency item.

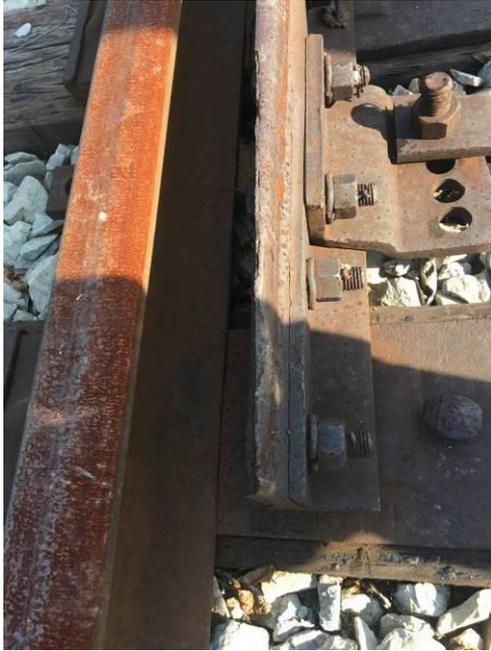
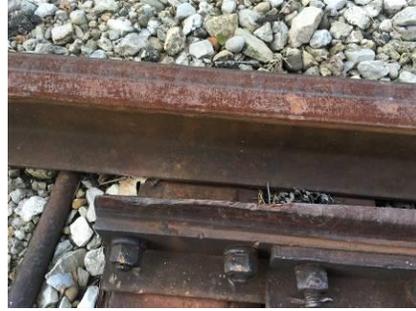
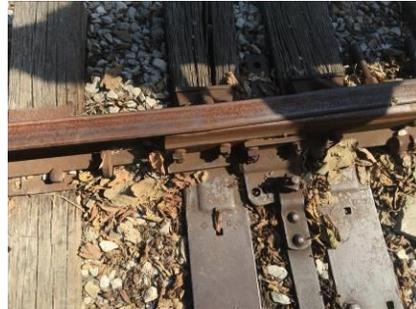
South of 46th Street Turnout – Clamped (out of service – O/S) turnout. Chipped right hand point. Braces are loose and switch timber throughout the turnout are poor. Frog is poor and should be replaced or at least the risers welded. This is where the aforementioned stainless steel bead commences heading south.

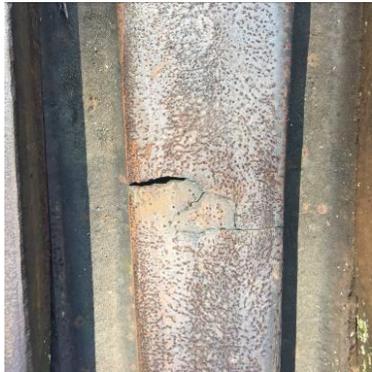
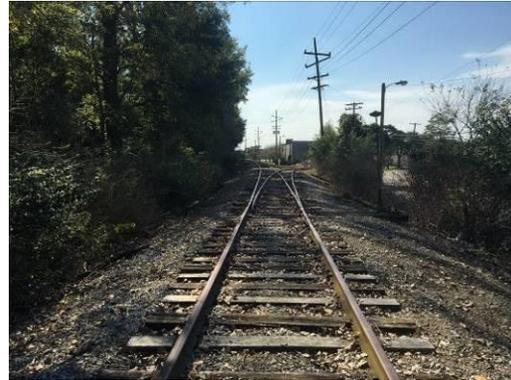
South of 56th Street Turnout – O/S, Frog is poor, reverse move back to back measurement is O/S, Frog needs replaced.

A cracked frog point is sometimes “weld-able” if it does not migrate through the entire point and definitely into the casting. It has been the prudent action to simply replace the frog then to attempt to cut out the fracture and build the point from scratch. Even the best of frog welders cannot always make a weld of this magnitude and have it last for any length of time. The fact that the track will be raised to Class Two level of service negates the option of welding. The frog must be replaced.

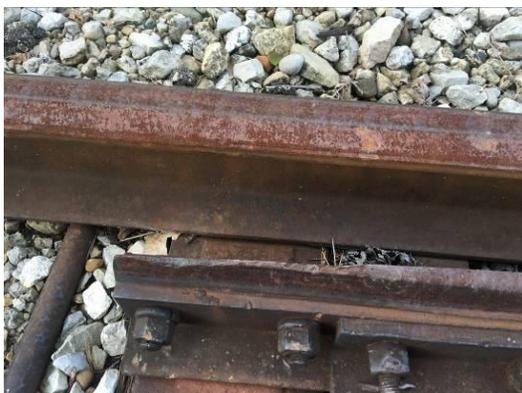
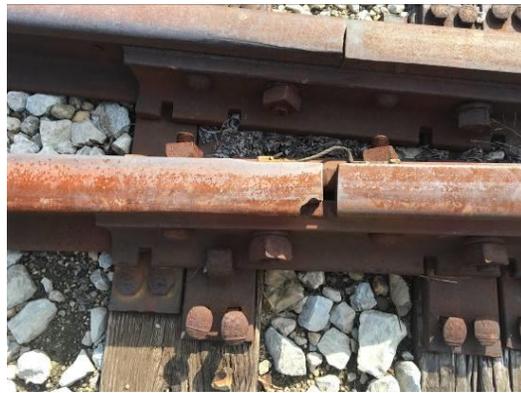
South of 82nd Street Crossing – Chipped left hand point needs welding. Needs headblock timber (gauge rod at location presently), worn frog but fair. Small 1-1/4” break out off a rail trailing out of the frog. It will be replaced in the miscellaneous rail replacement item in during the rehabilitation. Heel block missing a bolt.

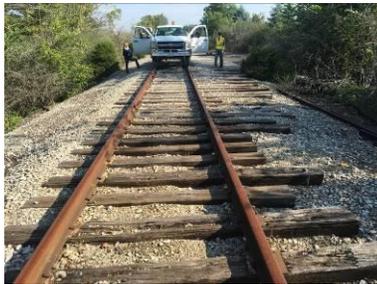
South of 96th Street Crossing – Clamped for normal moves O/S. Discussed above regarding the drainage. Chipped left hand point, loose bolts in frog area and worn risers that need welding. Poor switch timber through closure and frog. Right hand stock rail tread worn.

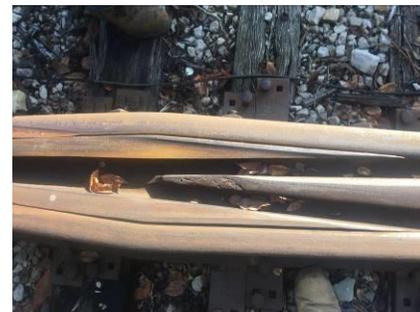
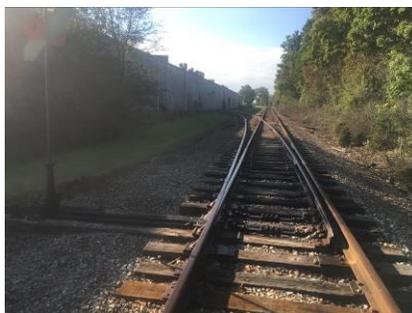
North of 146th Street Turnout – Poor timber on trailing end. Chipped switch point four inches long requires minor weld. Reverse move Check and Face measurements need correction. Frog point needs welded.

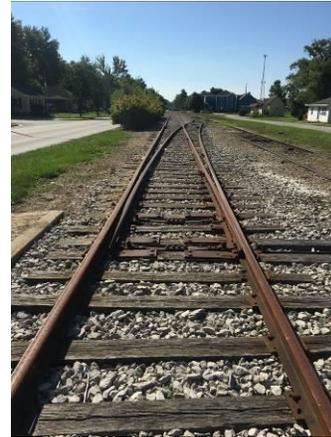
S. of Chestnut St Turnout

South of Chestnut Street Turnout – Joints approaching frog are loose. Braces slightly loose. Loose frog bolts.

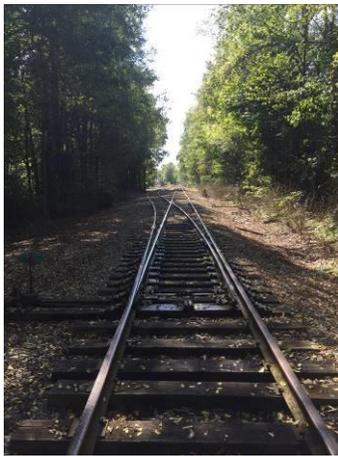
North Indiana Transportation Museum – Frog point needs welded. Switch rods are rubbing against switch timber.

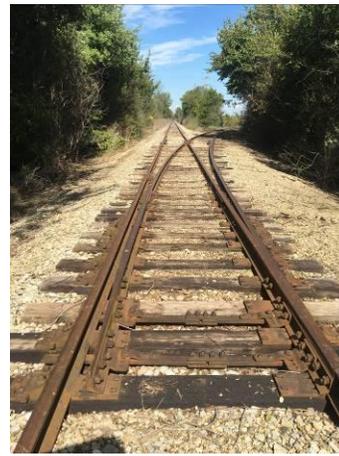
South Wye Turnout – Frog bolts are loose.

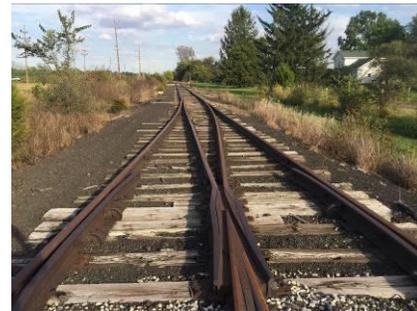
East Wye Turnout (off the Main Track) – Needs headblock timber (Switch machine timber) and point and closure rail timber.

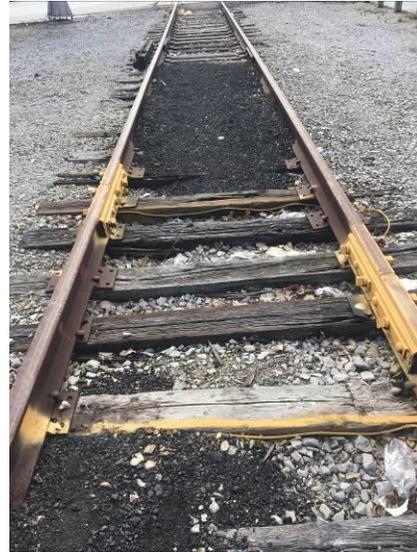
MP 5.1 – 38th Street

MP 5.1 - 38th Street The north approach to the crossing will require additional cross ties. Typical and similar to a production tie replacement gang at inner track guard rails over bridges, insulated joint ties that require replacement are often overlooked because of the fear of breaking the wires, especially if there is not a signal maintainer available to repair them. The track looks solid as evidenced by road traffic but there are numerous inside rubber flanges missing.

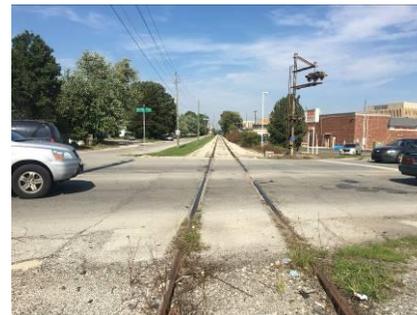
MP 6.2 – 46th Street Crossing like many more below do not have a positive flangeway. Track is relatively solid.

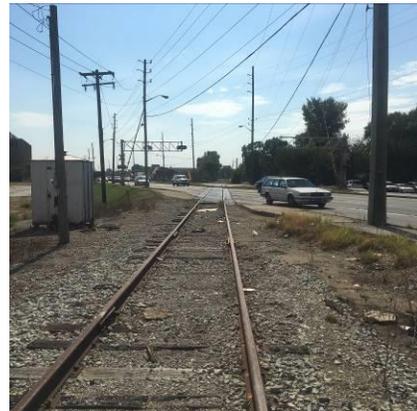
MP 6.4 – Keystone Avenue Poor alignment and drainage approaching crossing. Ties are fair in median and track looks solid under crossing.

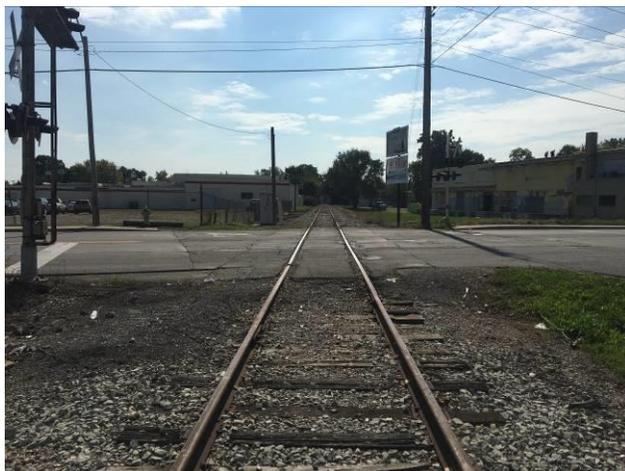
MP 6.7 – 52nd Street

MP 6.7 - 52nd Street No positive flangeway grade crossing.

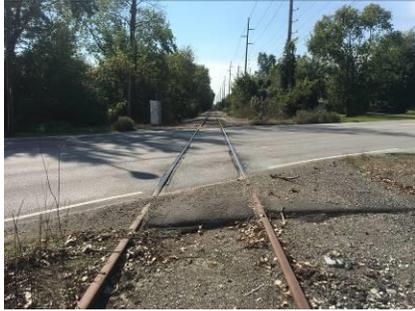
MP 8.0 – Kessler Blvd. No positive flangeway, track solid.

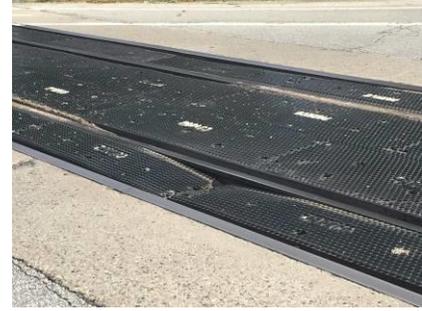
MP 8.5 – Allison Road Four panels are failing and should be removed and asphalt paved, track solid.

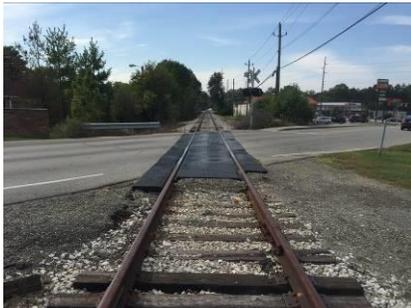
MP 8.7 – 62nd Street Both rails within the crossing are vertically bouncing with vehicle traffic, crossing must be fully replaced.

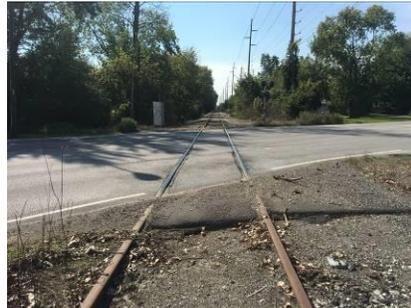
MP 10.3 – 71st Street Asphalt, no positive flangeway. Track solid.

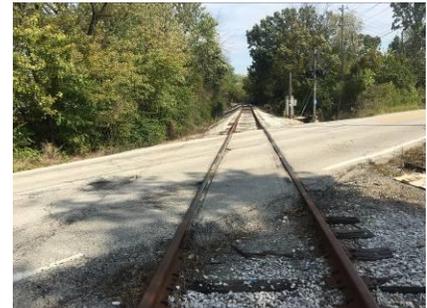
MP 11.0 – 75th Street Asphalt, no positive flangeway. Track solid.

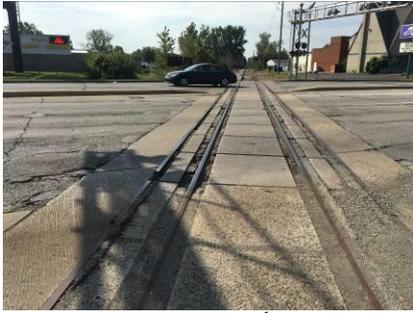
MP 12.3 – 82nd Street

MP 12.3 - 82nd Street Tub crossing mild misalignment in crossing at median. Broken up asphalt in flanges. Track appears solid.

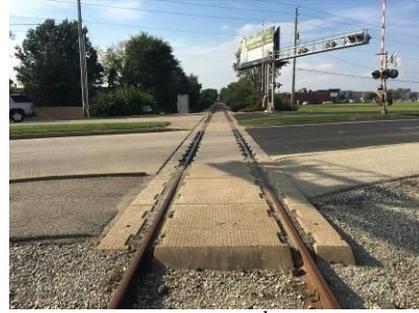
MP 13.7 – 96th Street Concrete tub crossing, solid track.

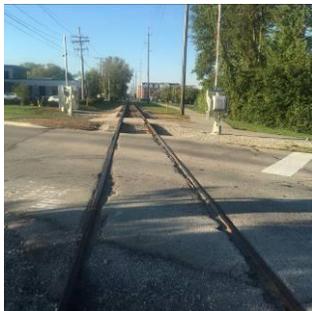
MP 16.5 – Lantern Road Asphalt, no positive flangeway.

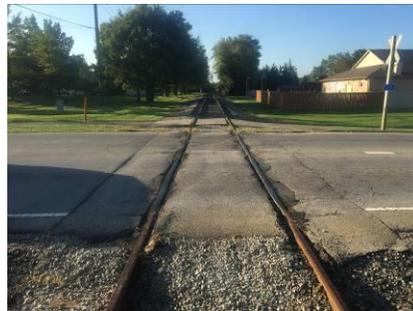
MP 17.3 – 126th Street Broken up asphalt with no positive flangeway. Track appears solid.

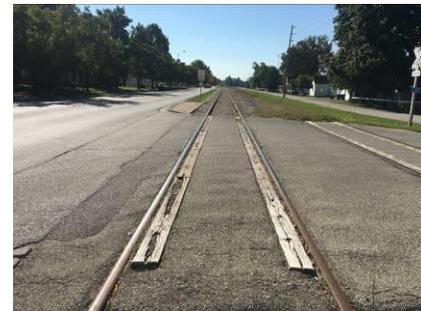
MP 21.3 - Chestnut

MP 21.3 – Chestnut Timber flangeway, some failing but track structure appears solid.

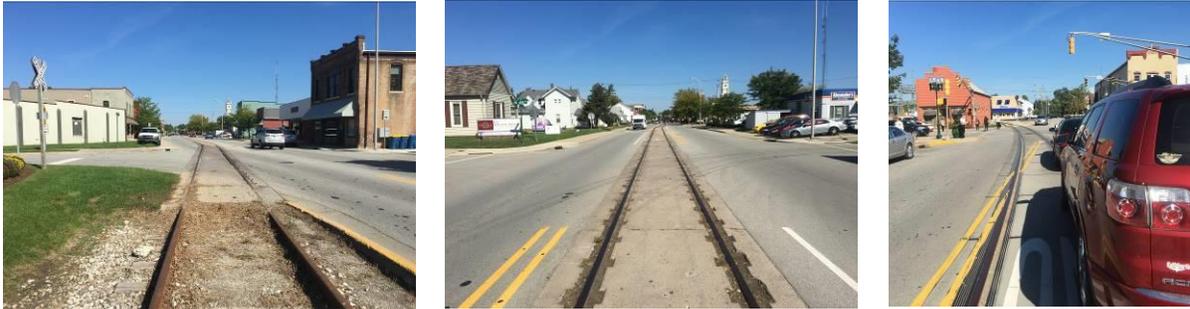
MP 21.8 – Division Street through Logan Street Embedded street running track in concrete tubs with continuous welded rail. Sturdy track.

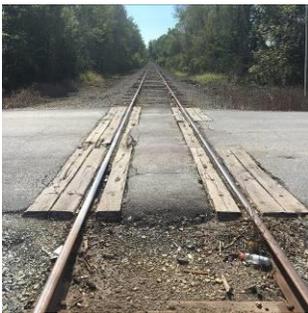
MP 24.5 – 196th Street West rail is loose in the crossing and vibrating under vehicle traffic. Crossing requires full replacement of track and surface.

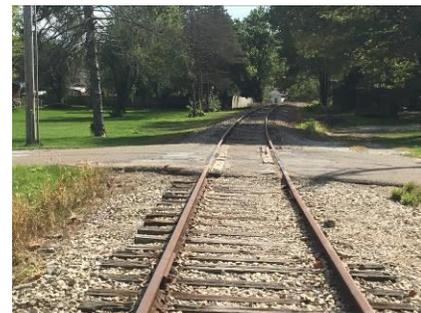
MP 28.9 – Park Street Broken up timber crossing. Scheduled to be replaced in spring.

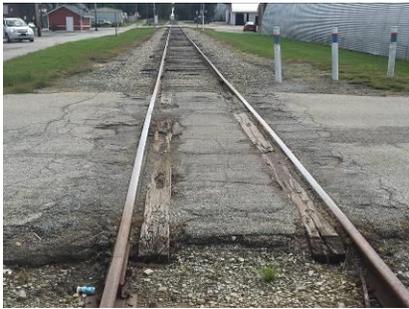
MP 31.7 – North Street Broken up flangeway timbers, may be considered for full replacement.

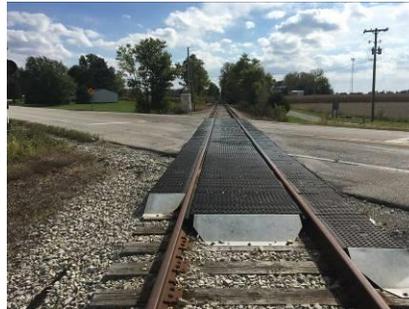
MP 34.1 – State Route 19 Good crossing – deserves a picture.

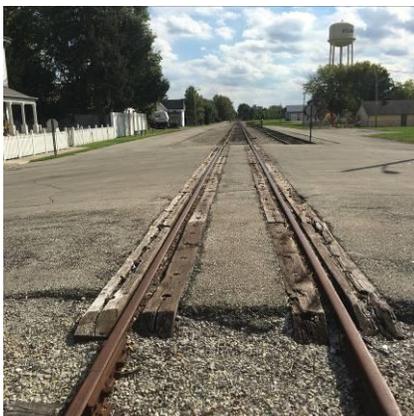
MP 34.4 – Main Street Similar to Kauffman Street, failing flangeway timbers should be removed and asphalt paving should provide flangeway.

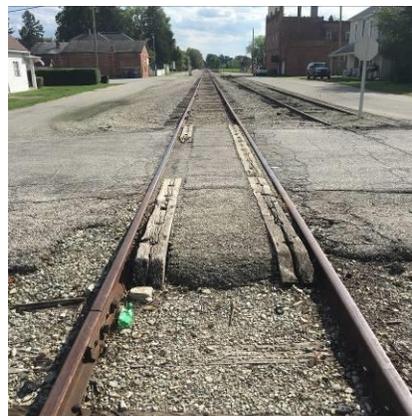
MP 34.5 – Meridian Street Flangeway timber was removed and paved in as recommended above, but the flangeway was not provided. Also, lags that may be surfacing out of the broken timbers should be removed to avoid damaging vehicle traffic. Therefore, some timbers should be removed just because the lags are not securing them down.

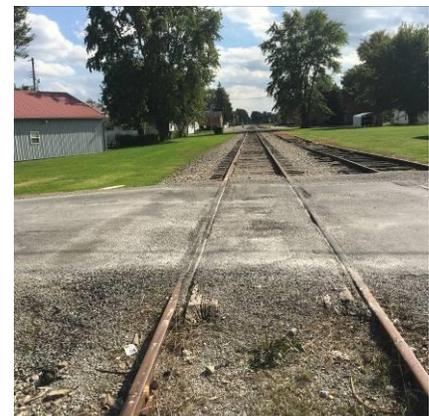
MP 34.6 – County Line Road Flangeways must be provided for train movements.

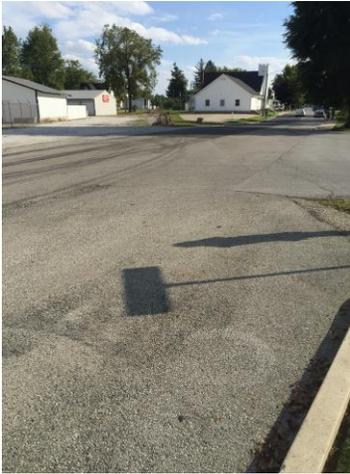
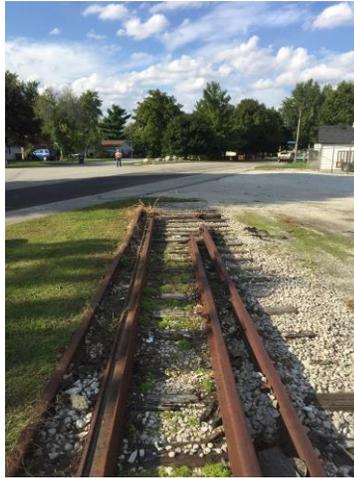
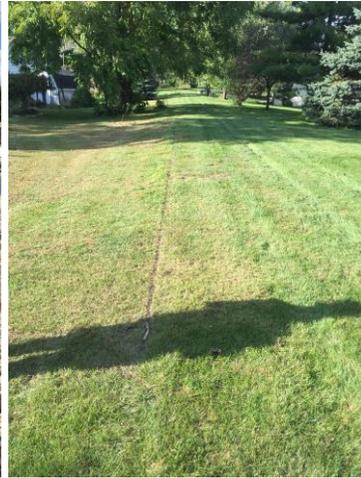
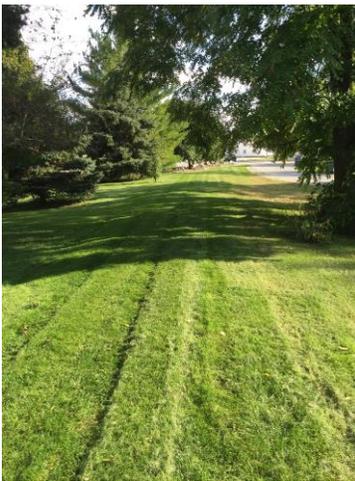
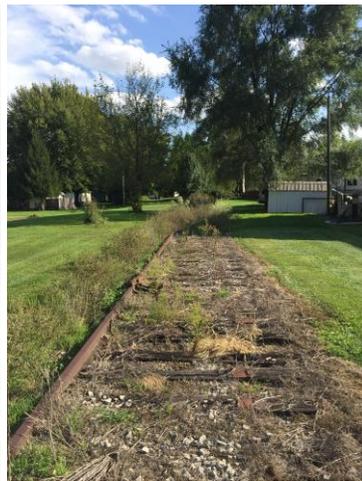
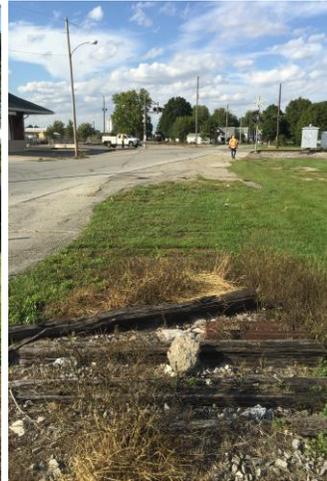
removed at North Street and Independence Streets, then partially or completely covered with grass and dirt through to Main Street. The track appears to be removed under Main Street.

As the pictures show there is some considerable work to perform to rebuild the track and grade crossings just to access the Norfolk Southern Mainline. As a general note, the track covered with dirt and grass is probably not reusable. Typically rail and other track materials (OTM) will corrode when buried in dirt and debris. If the rail is adequate it can be utilized as inventory for siding and spur tracks.
